# **Smoke and Dye Testing Summary**

## **High Level Sewershed**

Run Summa	ary <del> </del>						
Test ID	Test Type	Date Inspected	Company / Super.	Blower MH	Ground Condition	Notification Made?	Total Length
S1028-211	Smoke	8/4/2009	ADS/TM	S17A019MH	Dry	Yes	475.41

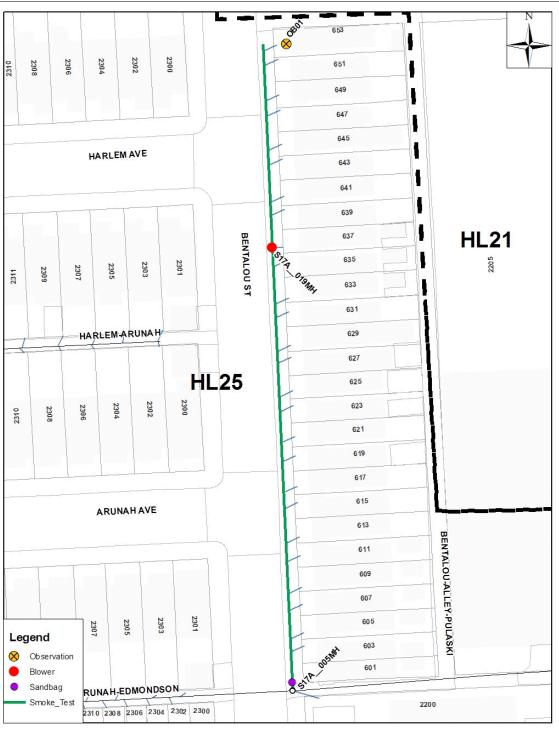
**Picture** \S1028-211-OB01-P01.jpg

**Obs\_ID** \$1028-211-OB01 **Address** 653 Bentalou St.

Status Private
Source Cleanout

**Location** Yard - front **Nearest MH** S17A\_\_019MH

**Comments** Smoke from cleanout in front yard. 653

Bentalou St.
